CERL Technical Report 99/37  
May 1999

# **Robotic Underwater Corrosion Inspection/Assessment of Sheet Pile Along Two Rivers at Cleveland, Ohio**

## **Cuyahoga River Bulkhead Study: Phase 2 Report**

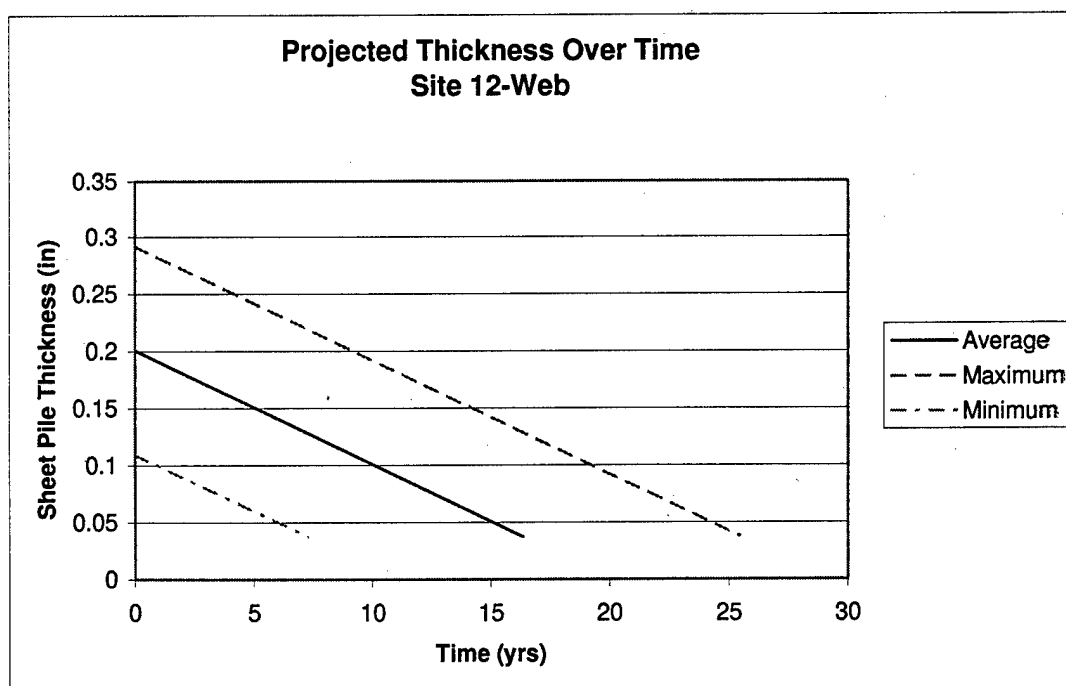
Figure 22. Site 12 web thickness projected over time.

Zebra mussels are present in Lake Erie, but they were not found in great numbers at any site surveyed except for Site 12. Since Site 12 is closest to Lake Erie, a reasonable conjecture is that the encroachment of zebra mussels will proceed inland, assuming adequate initial environmental conditions for growth and reproduction. Although the rate of this migration is unknown, it is likely to adversely affect the corrosion rate of installed sheet pile. Experience at Black Rock Lock in Buffalo, NY, suggests that zebra mussels increase the corrosion rate by a factor of 5 compared to the rate in noninfested water. On the plus side, as filter feeders, the Zebra mussels are likely to have a positive effect on the clarity of Cuyahoga River water. It seems prudent therefore, to verify both the encroachment patterns and accelerated corrosion rates before considering available options for control.
